Manhole Inspection Summary

Manhole # S41AA_017MH

Insp Date: **11/11/08 9:31 AM**

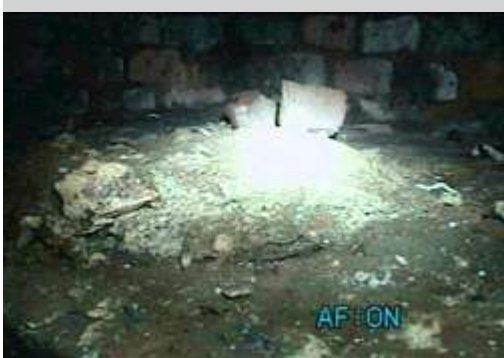
Defect 3

Bench ☒ Exists Material: **Brick** ☐ Parged
Condition: ☐ Sound ☐ Cracked ☐ Root Intrusion ☐ Deteriorated ☐ Leaks ☒ **Debris**

bench debris

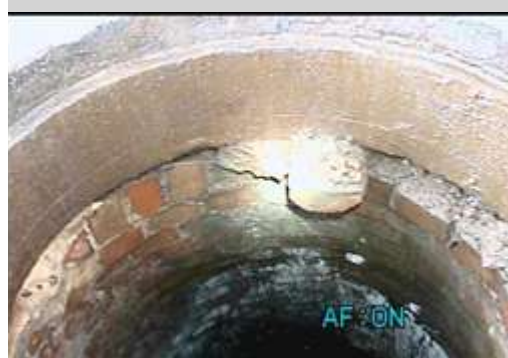
Defect 2

Frame Offset: **0** (in.) Condition: ☐ Sound ☐ Cracked ☒ **Leaks**

Chimney / Frame Adjustment ☒ Exists Material: **Brick and Concrete** ☐ Parged Height: **7** (in.)
Condition: ☐ Sound ☐ Cracked ☐ Root Intrusion ☒ **Loose Brick** ☒ **Deteriorated**
Infiltration: ☒ None ☐ Joint ☐ Cracks ☐ Mortar ☐ Roots ☐ Wall

chimney loose bricks deteriorated at frame joint, frame leaks

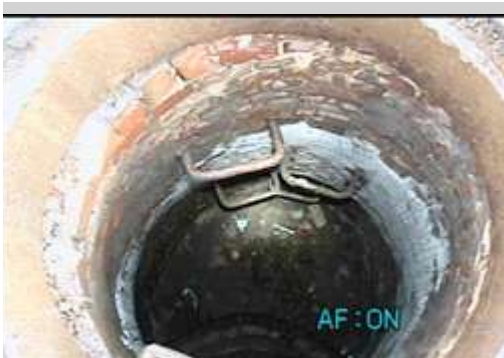
Defect 1

Steps Count: **4** Missing: **0** ☒ **Corroded**

steps corroded

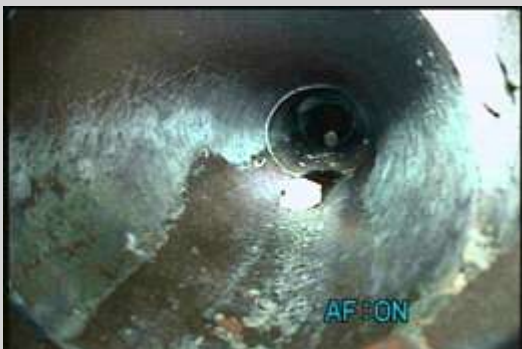
9 O'Clock Inflow

Deposits: ☐ None ☐ Mud ☐ Sludge ☒ **Debris** ☐ Grease

Silt Depth: 2 (in.) Deposits Extent: **Light**
